Laboratory Reproduction and Failure Analysis of Cracked Orbiter Reaction Control System Niobium Thruster Injectors

**Jeremy B. Jacobs
&
Willard L. Castner**

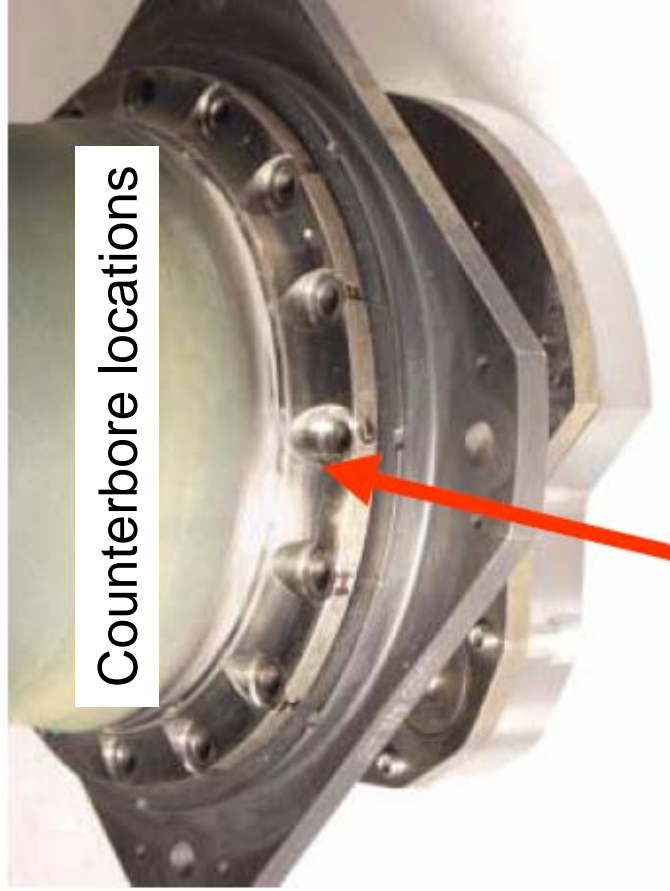
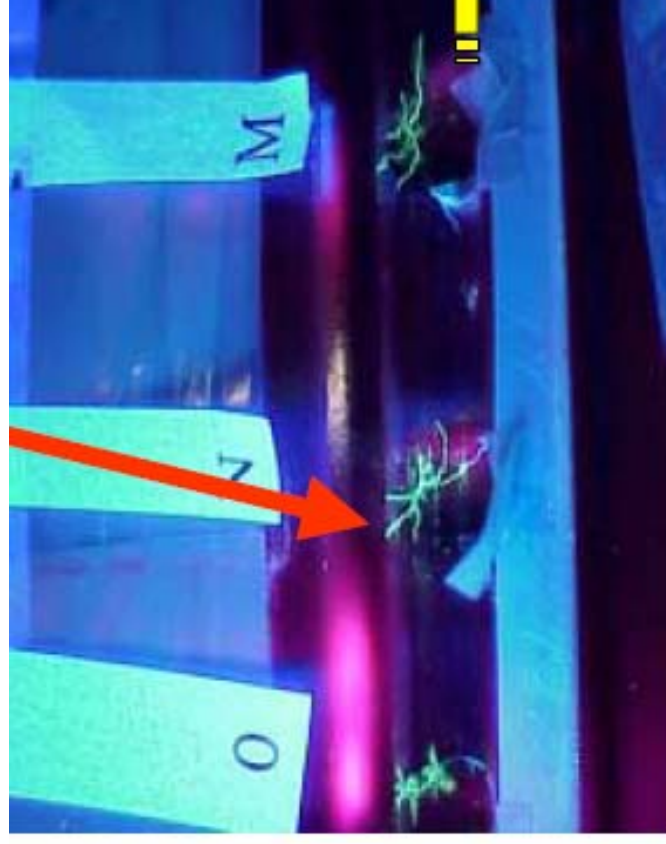
Counterbore Cracks

- Counter bore cracks found near new nozzle EB weld
- First time such cracks found, discovered incidentally (penetrant inspection)
- Relief radius cracks similar to 1979/1982 subsequently found

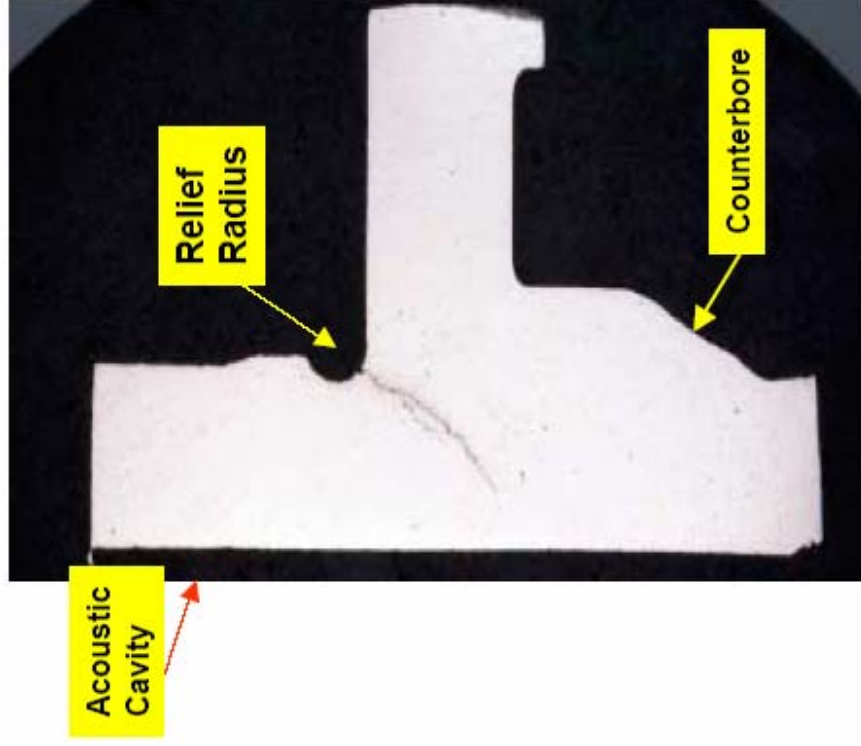
Relief Radius Cracks

Crack extending from **relief radius** towards acoustic cavity

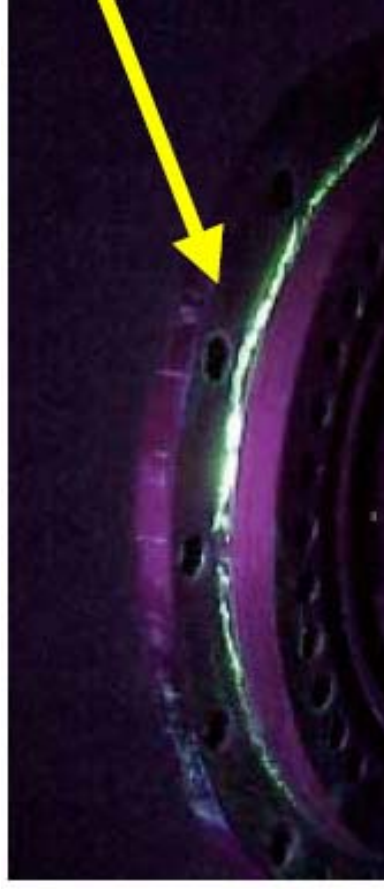
Penetrant indication

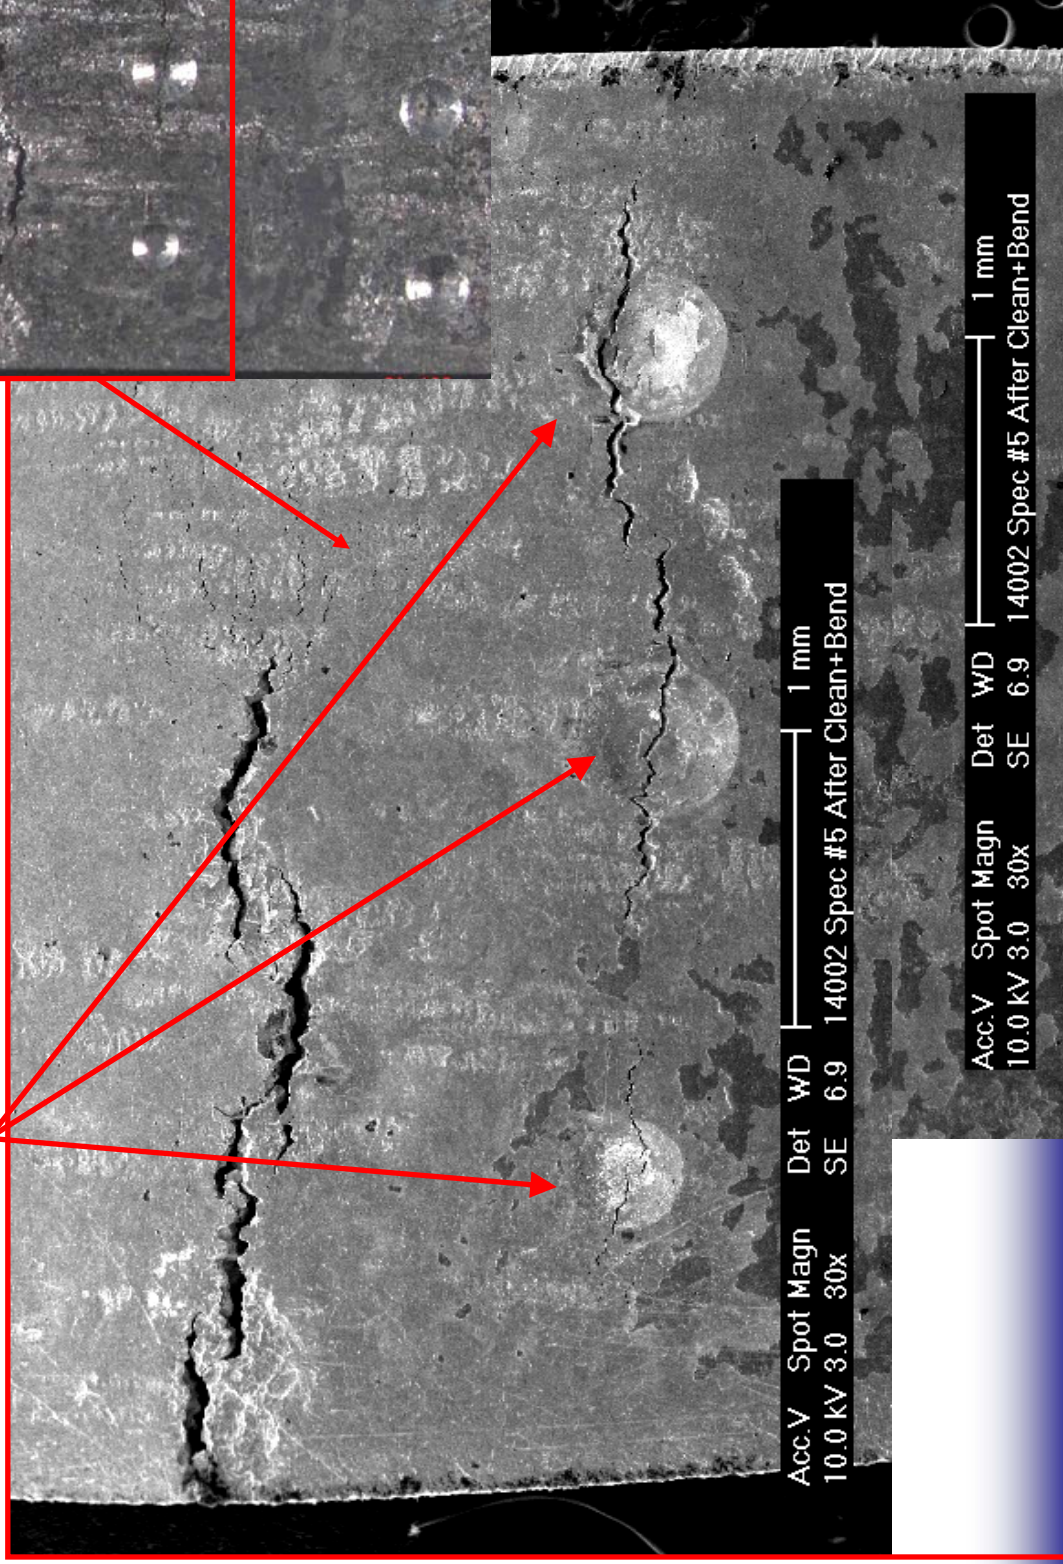
Specimen #5 – HF + 600F

- 3 IG Crack Initiation Sites
(Correspond to Hardness Indents)

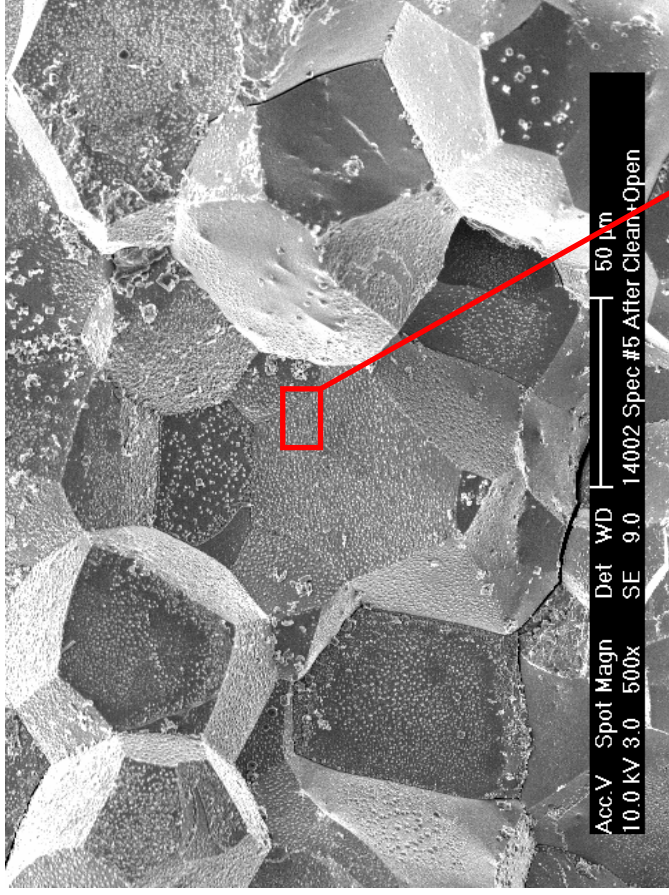
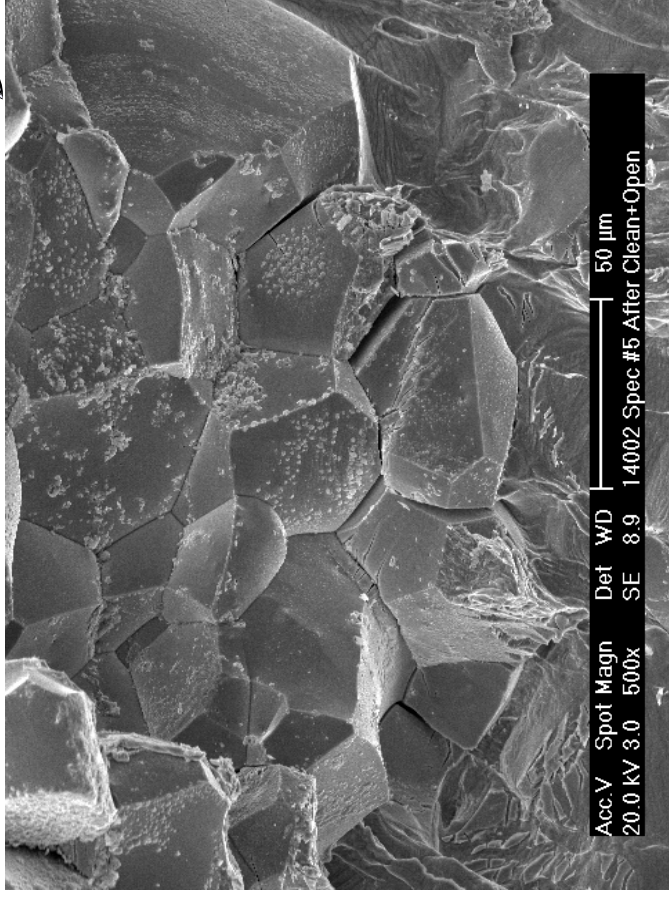
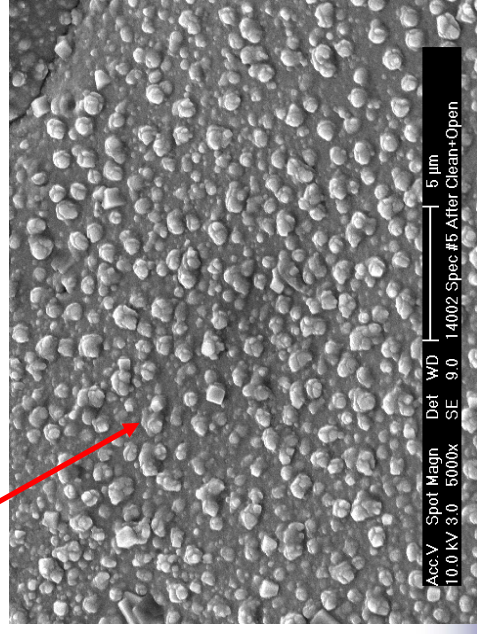
Specimen #5 – “Popcorn”

Near Origin

Near Termination

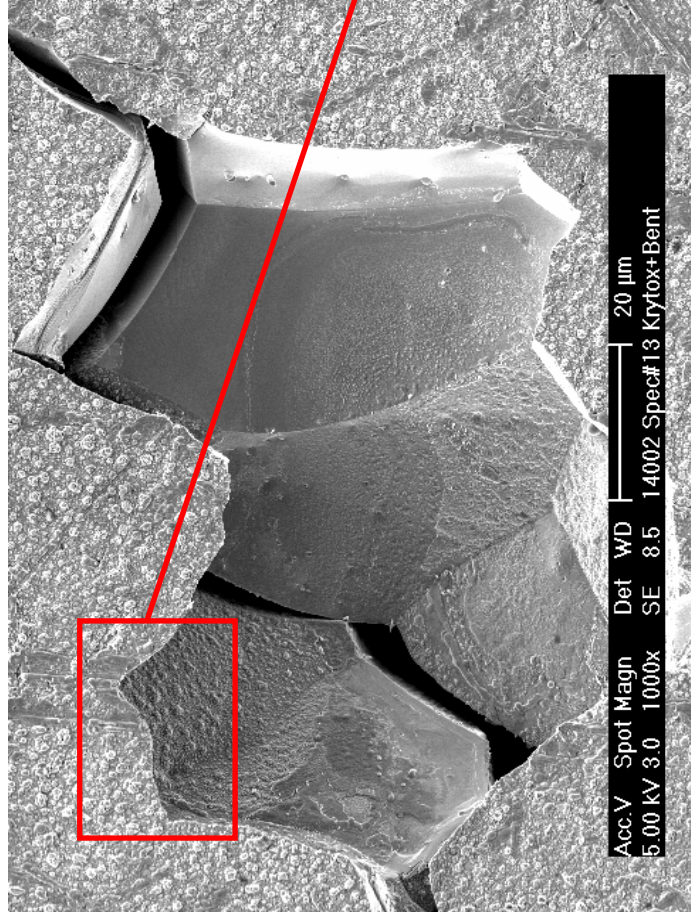
Missing Grains
at Crack Origin

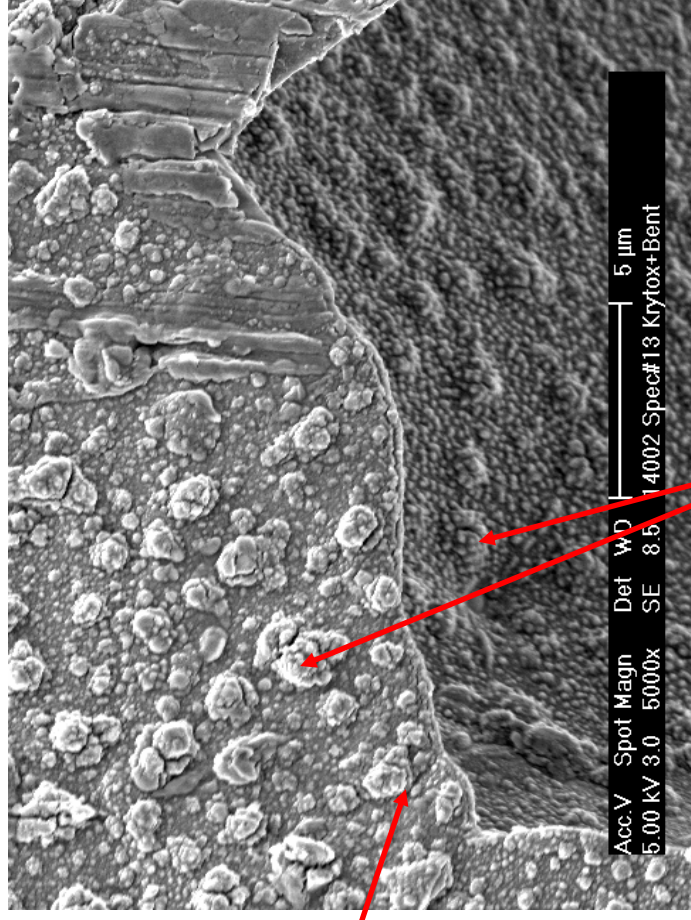
“Popcorn” on
Free Surface +
IG Crack

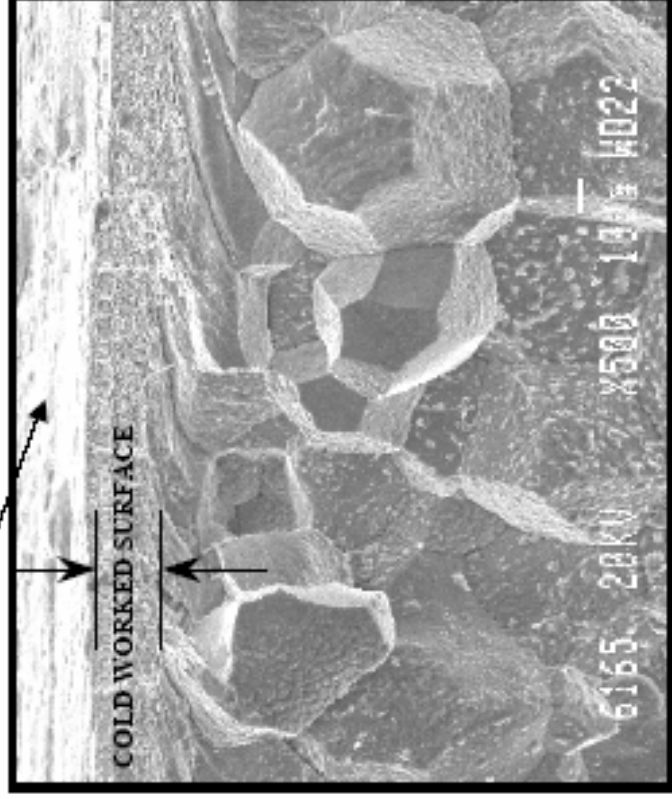
Overview of fracture face

Cold worked surface layer and intergranular facets in failure origin area

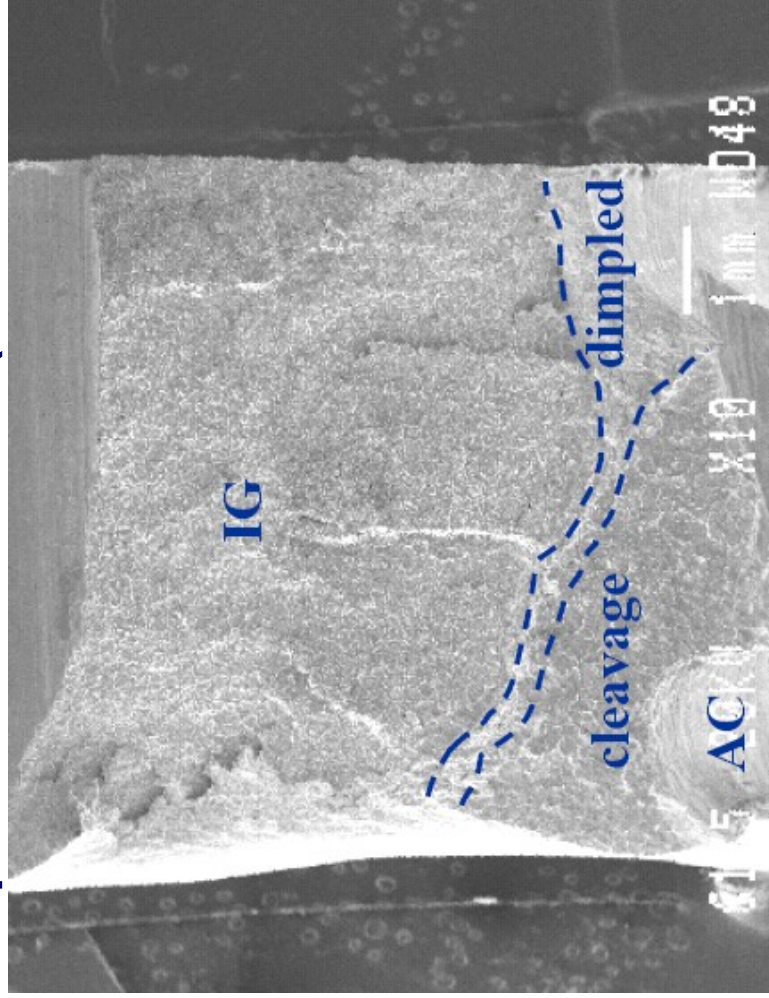
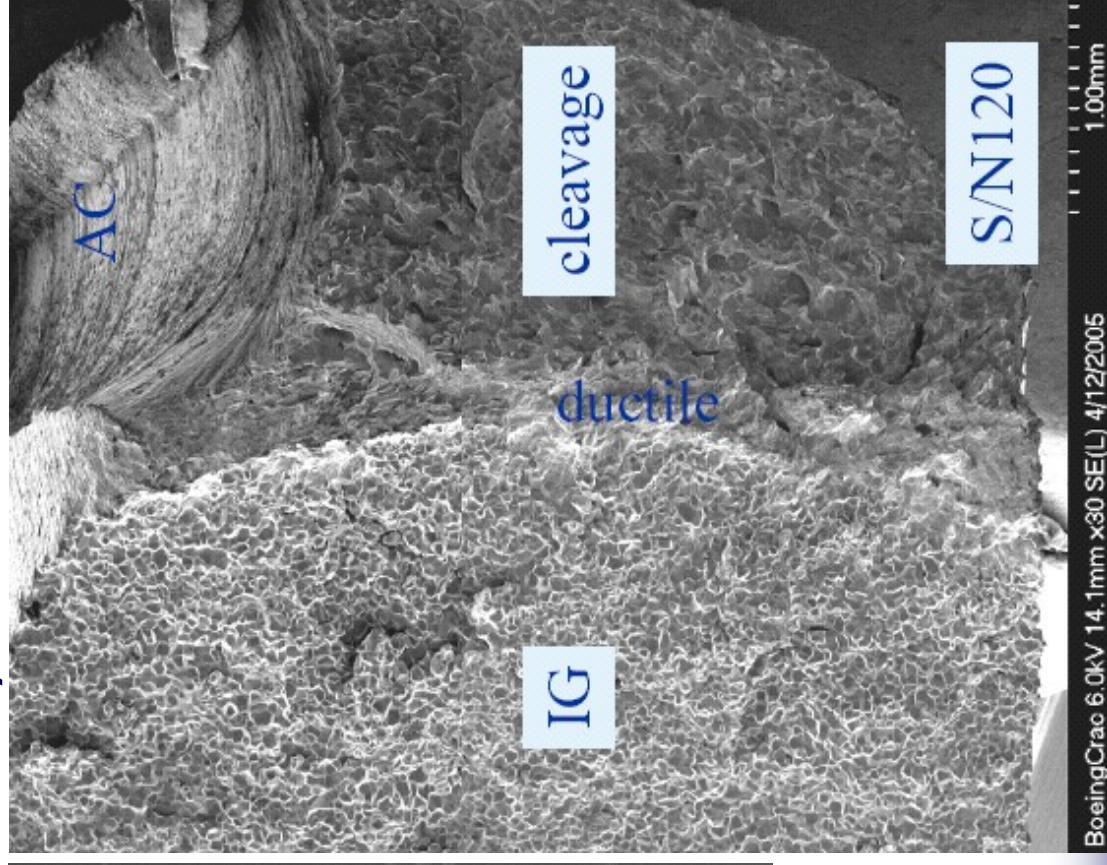
Opened Relief Radius (Between Holes J & K)

Cleavage Fracture on S/N 120
